**BUILDING EVALUATION AND
RESERVE FUND STUDY**

*BELLA VITA AT GREEN TEE
1548 N. RIVIERA CIRCLE
PEARLAND, TX 77584*

MAY 11, 2008

Project Number: 2008050

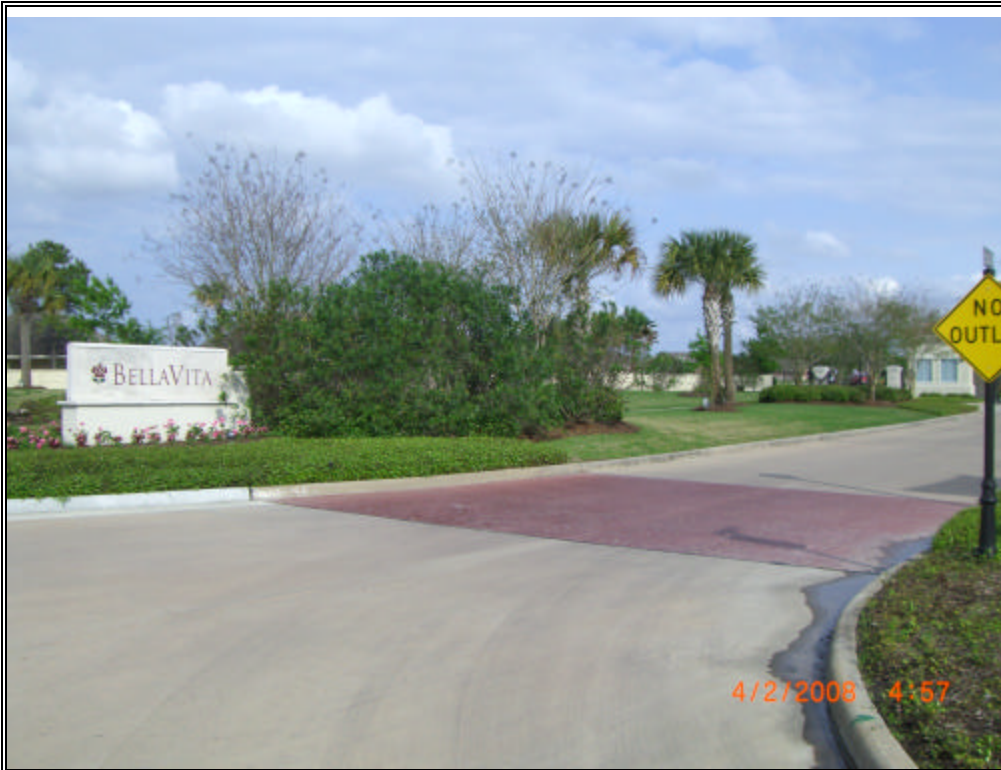
Photo Number
1

The property signage was in good condition. These components on the property should provide years of relatively trouble-free service. We have included an item in the budget to repair the signage every 20 years.

Description:
Community
Entrance and
Monument Sign

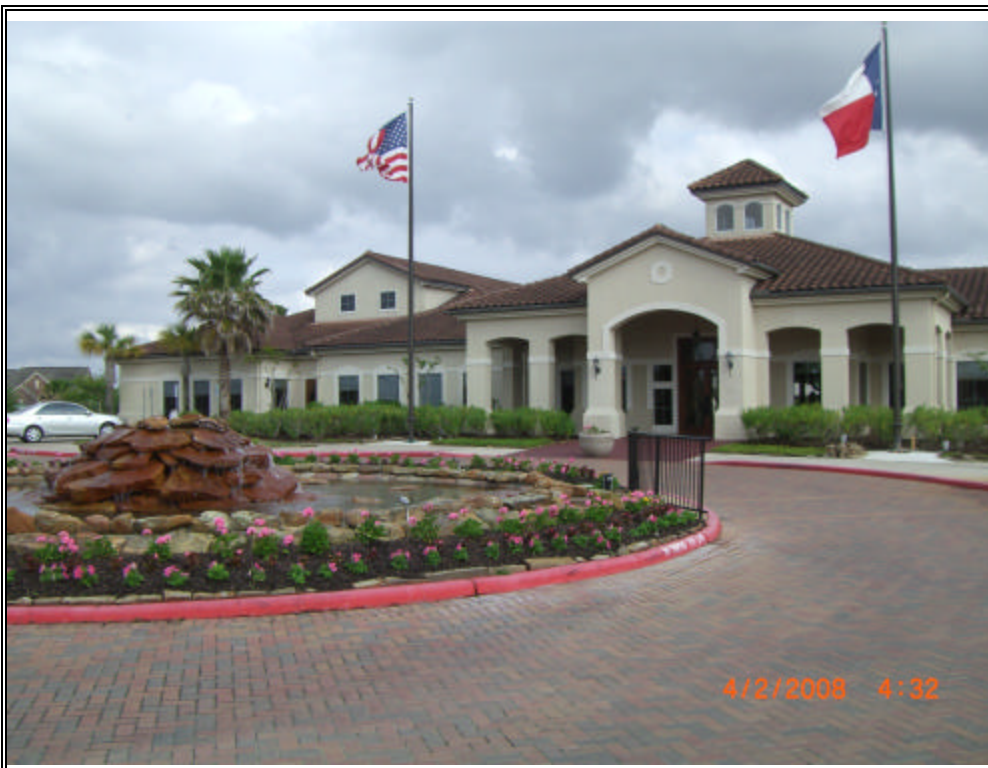
Photo Number
2

The brick paving at the fountain area was in good condition and should be expected to have localized damage that can be repaired on a regular basis. We believe you should expect to replace 20% of the bricks every five years.

Description:
Clubhouse and
Circular Brick
Paver Driveway

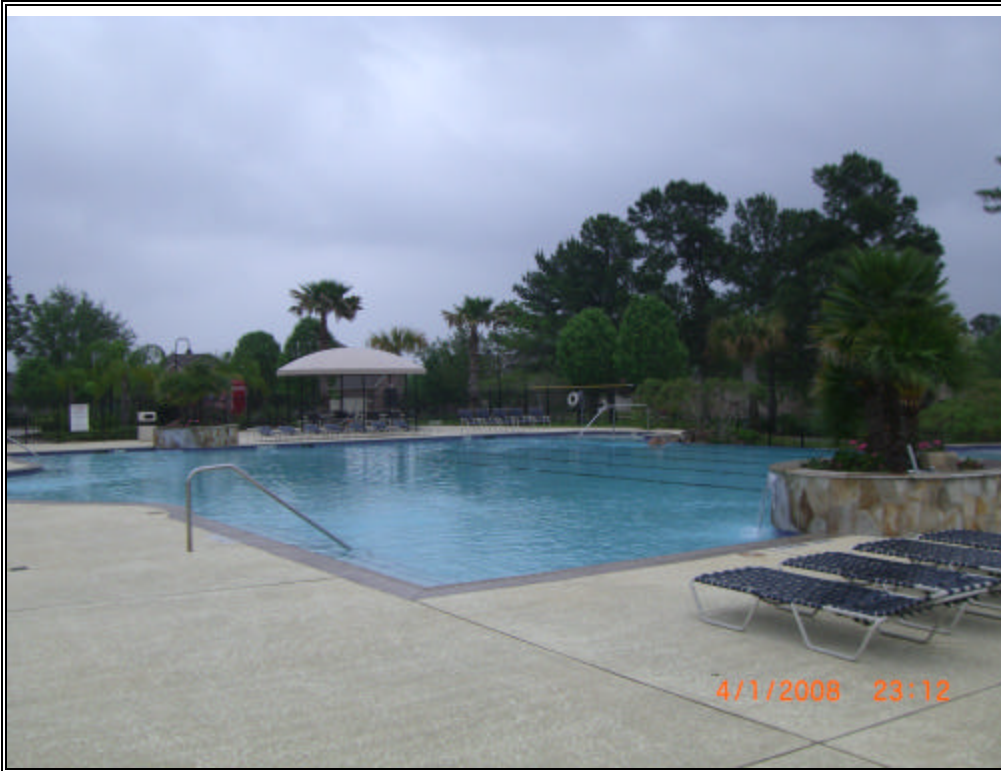
Photo Number
5

The swimming pool was in good condition and we did not note any spalling of the plaster. Pool plastering usually needs to occur every 15 years (if appropriate maintenance has been completed) and this has been included in the study.

Description:
Community Pool

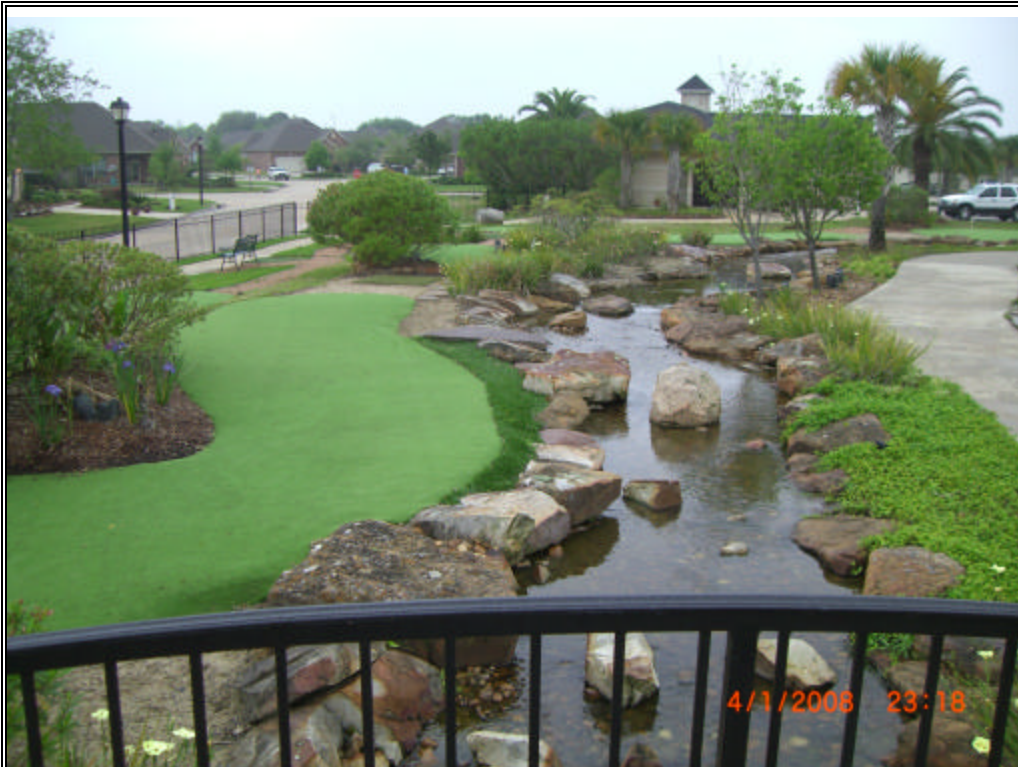
Photo Number
10

The nine-hole putting green was in good condition. You should expect periodic maintenance to keep the aesthetic appeal of this amenity in tact. This can be accomplished with the annual operating budget.

Description:
Babbling Brook
and 9 Hole Putting
Green

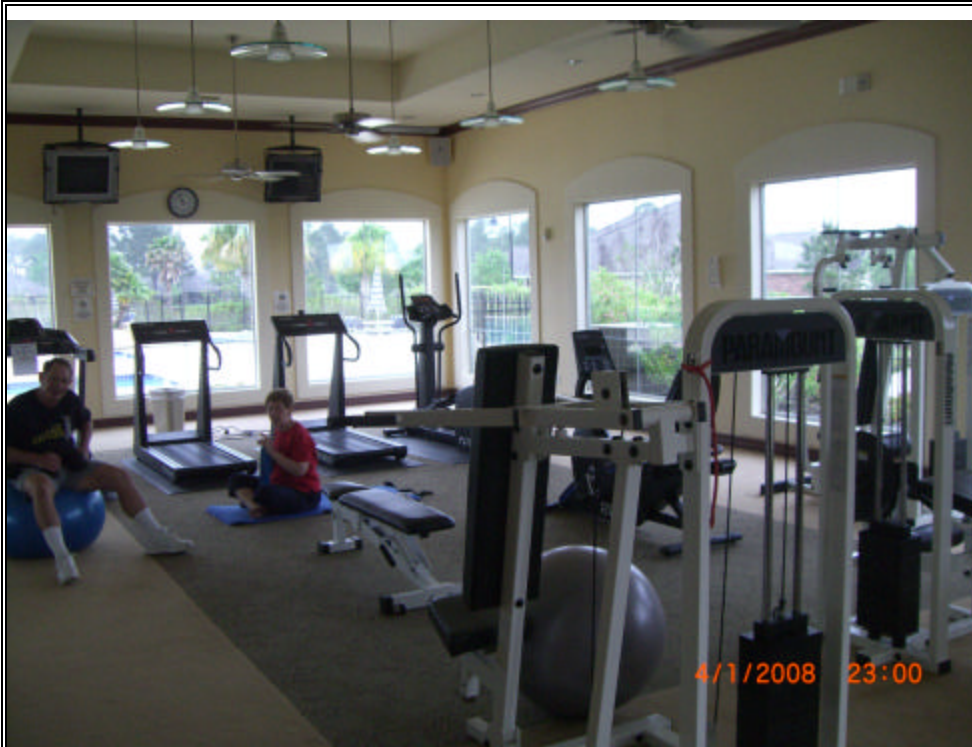
Photo Number
11

The exercise equipment was in good condition. The equipment consists of three treadmills, one elliptical trainer, one stationary bike, and 6 cable/pulley multi-station exercise machines. We have anticipated the need to replace this equipment every 12 years.

Description:
Exercise Room

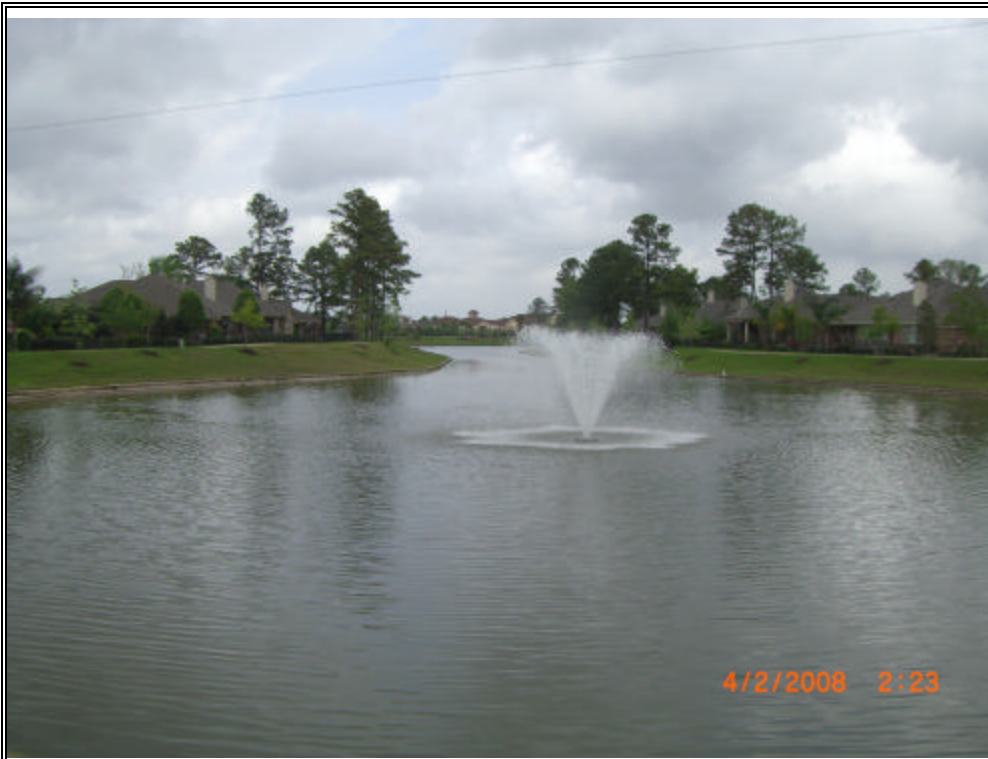
Photo Number
13

The retention ponds, at the time of the investigation, did not appear to have an algae growth problem, as exacerbated by stagnant conditions, indicating that water circulation through the system is adequate.

The retention system uses a system of 4 fountains (mechanical aeration systems) in the corners of the retention pond. These fountains inject air into the water helping keep the retention pond from developing algae and becoming clouded. The model number, motor size and type for the mechanical aerators were not readily available. We anticipate repair for the fountains every 8 years.

Description:
Retention Pond
and Aeration
Fountain

We have allocated a sum in the 14th year to fund a more in-depth study of the effectiveness of the pond and address issues such as vegetation control, possible erosion caused by sheet drainage, aesthetic issues, etc.

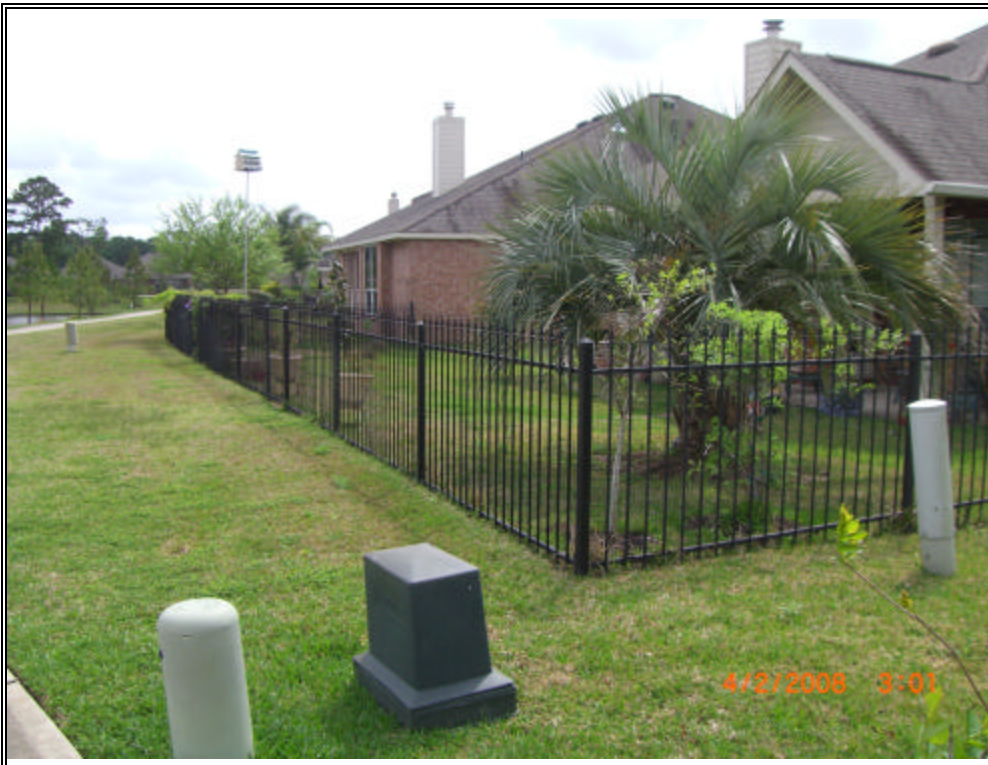
Photo Number
14

The wrought iron fencing was in good condition. Generally, repainting of this type of fence will need to be accomplished every five years to help delay corrosion and replacement is typical after 20 years of service.

Description:
Typical Wrought
Iron Fencing

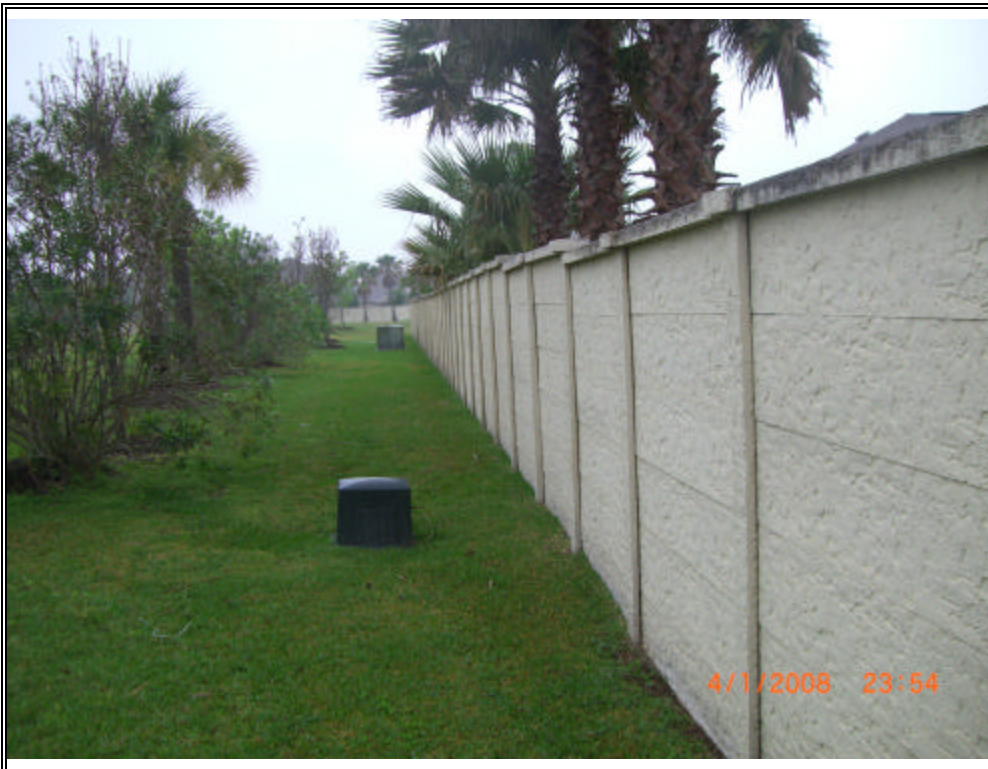
Photo Number
16

The concrete fencing along Scarsdale Boulevard and Bella Vita Drive was in good condition. Expansive soils, trees, and tree roots are primary factors in premature degradation of these walls and diligent maintenance in these areas will help provide longer life. It is our opinion that funds for repair of these walls should occur every 20 years for 10% of the sections.

Description:
Concrete Fencing
along Bella Vita
Drive and
Scarsdale
Boulevard
